Placenta Accreta: Images

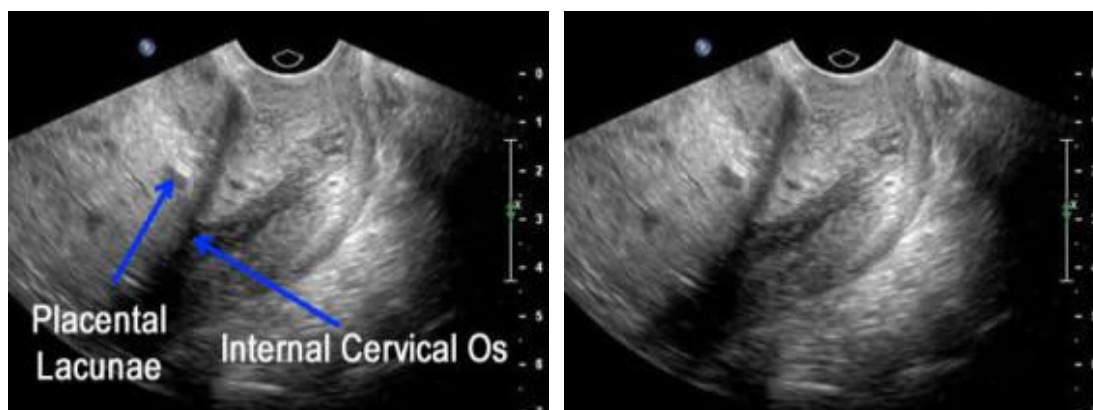
Above. Transvaginal ultrasound image in patient with previous C-section and placenta. Note small lacunae and the placental location over the internal cervical os (complete placenta previa).

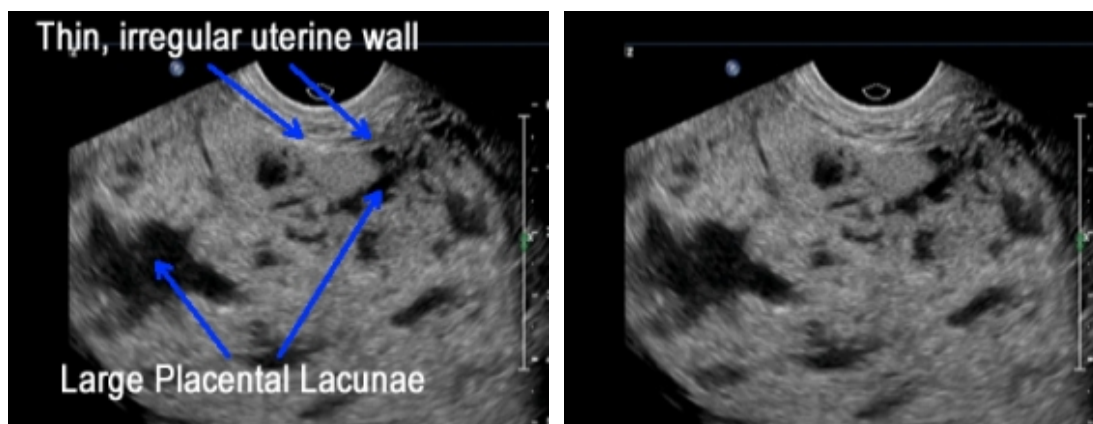
Above. Transvaginal ultrasound demonstrates placental lacunae in a patient with placenta accreta.

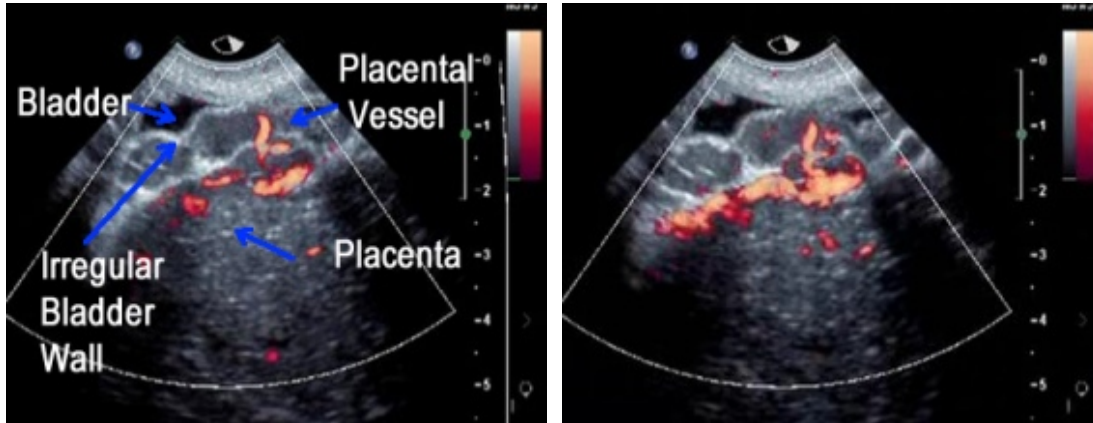
Above. Note precise color Doppler imaging demonstrates increased vascularity. There is increased vascularity and penetration of placental vessels to the myometrium.

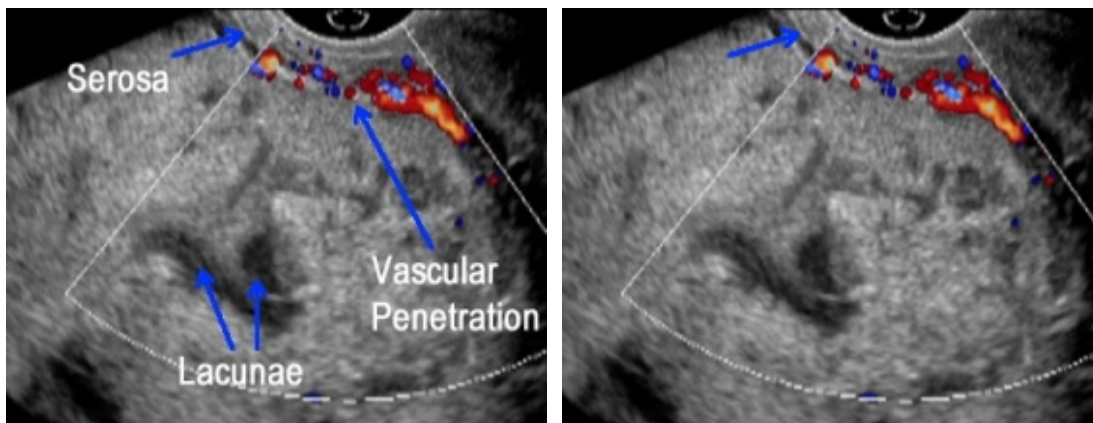
Above. Color Doppler imaging demonstrates increased vascularity, and potential penetration of placental vessels to the myometrium.

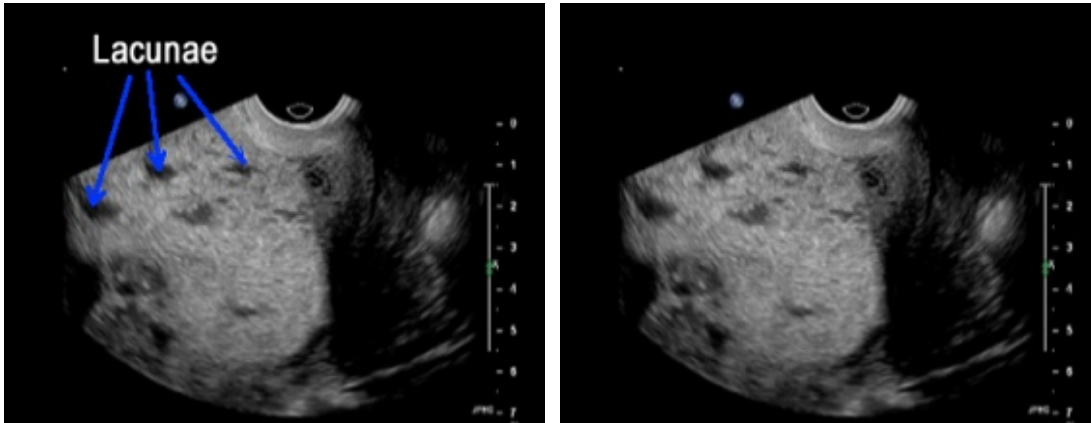
Above. Note relatively smaller lacunae in a patient at risk for placenta accreta.

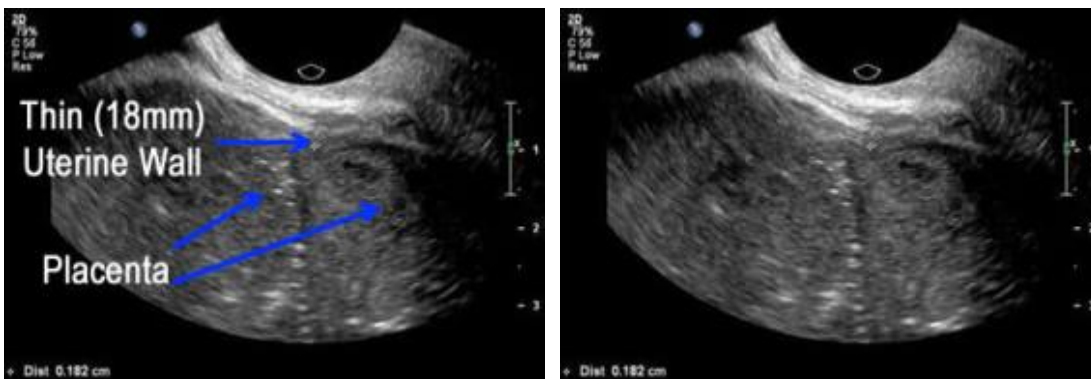
Above. Note relatively thin myometrium of 1.8 mm in a patient at risk for placenta accreta.

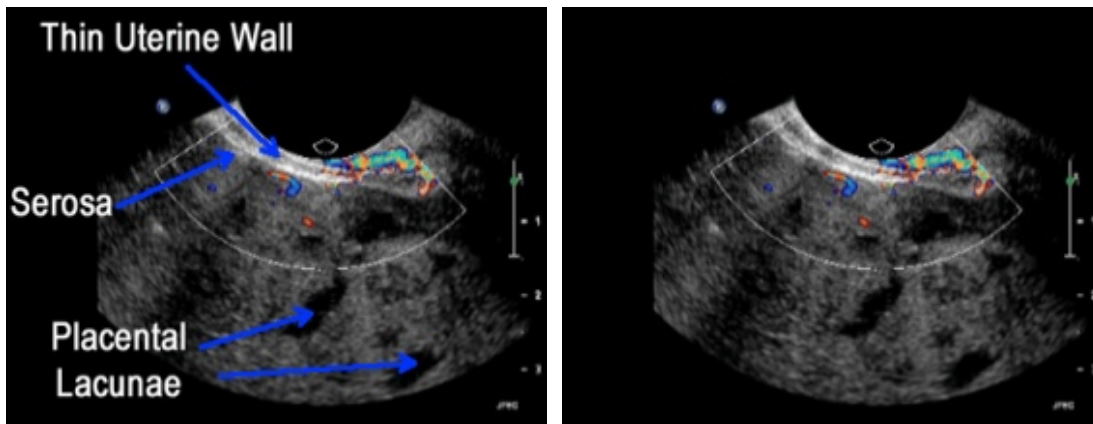
Above. Note the thin uterine wall and the large lacunae suggestive of placenta accreta.
